NORTECH GEOTECHNICAL/CIVIL CONSULTANTS, LTD.

> March 21, 2023 27382-49N

> Geotechnical Investigation Sierra Ranchos Rehabilitation Project Rancho Haven Community, Nevada

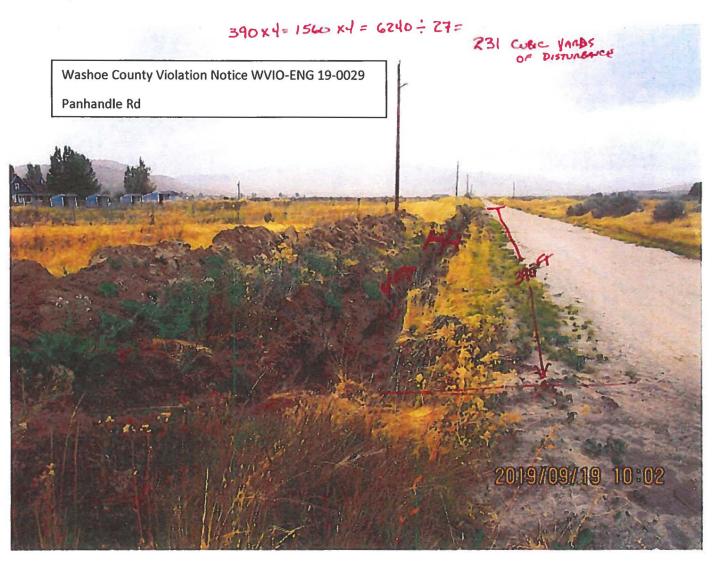
Image 18

Our field investigation took place January 5, 2023. Roadway conditions were poor, and travel was impeded due to surface defects such as potholes, washboards, ruts, and frozen sections of roadway. Photos are provided to document violation specific complaints reflecting the most current roadway conditions. WCC article 438 grading standard section 111.438.10 identifies the need for grading permits. Section 110.438.20 states no person shall do any grading in excess of fifty 50 cubic yards of material or 10,000 square feet of grading without first having obtained a grading permit from the building official as enforceable under the powers of Chapter 100. It should be noted upon our field visit of January 2023, no further grading or surface defects associated with grading were observed. Drainage channels were flowing with runoff due to snow melt. Photos 17 through 18 highlight the complaints from Washoe County, September 2019.

298 CUBIC YARDS OF DUTURBANCE

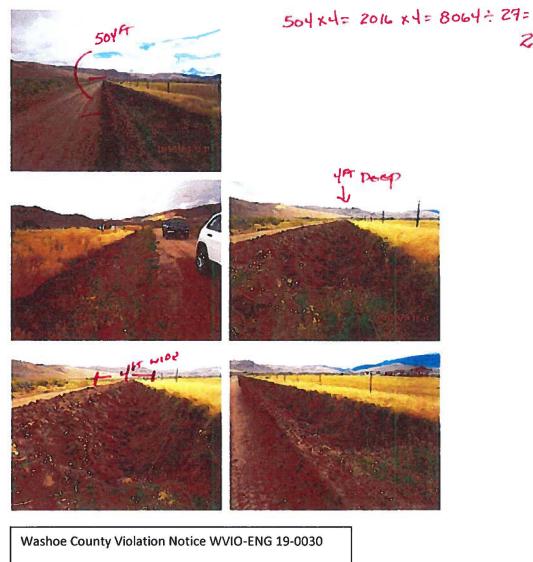
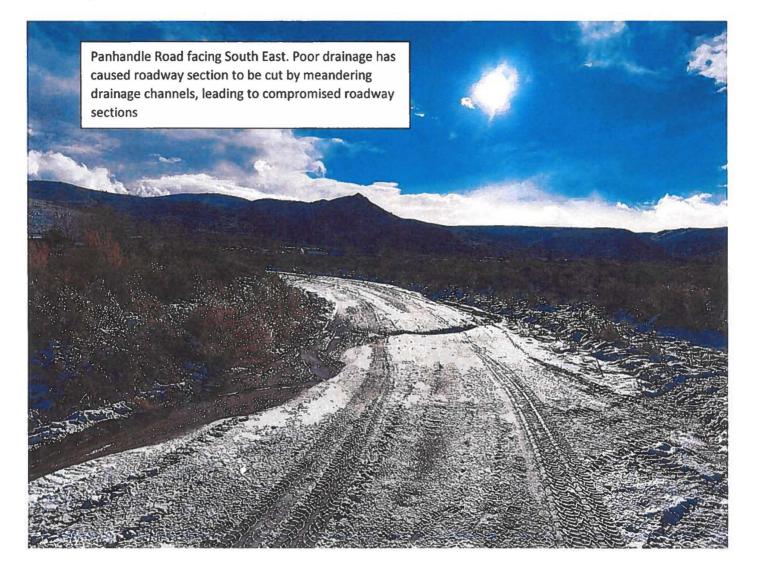
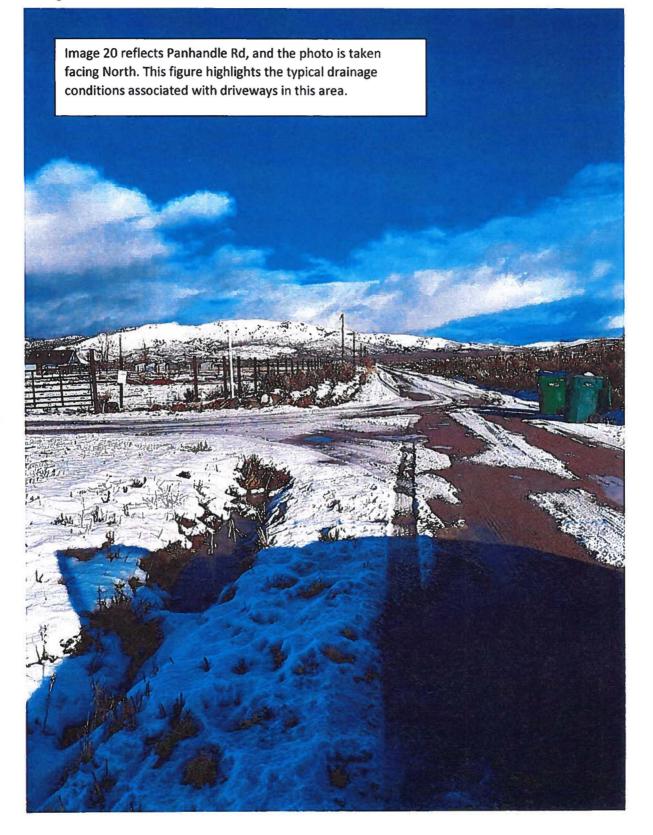
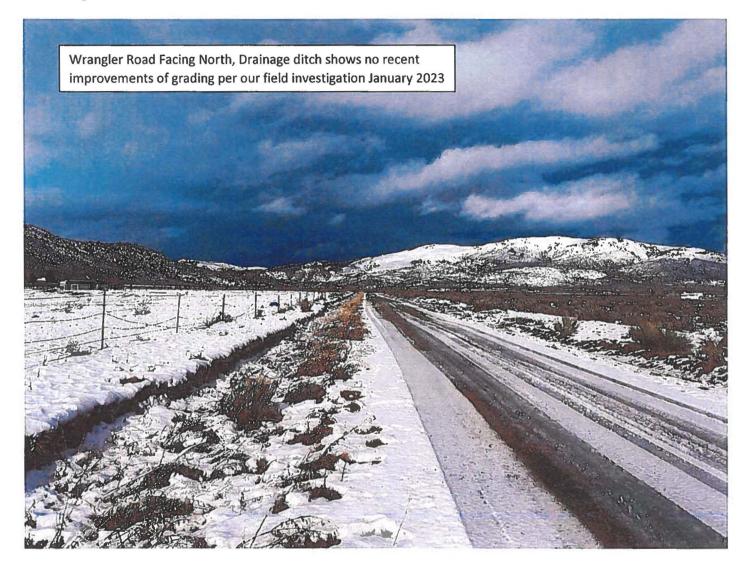
Photos 19 through 21 illustrate no recent grading excavations have been performed.

3. <u>Correcting Code Violations</u>: The roadway surface and drainage defects observed in the field apply to both Panhandle Road and Wrangler Road. Once the new drainage channels can be sized, and material can be excavated to the newly designed drainage channel depths and the final subgrades are established, the 8 inches of recycled asphalt base can be placed and compacted.
